TCNA TEST REPORT NUMBER: TCNA-579-15

TEST SUBJECT MATERIAL: System identified by client: "Laminam 5.6 with MLT System"

TEST PROCEDURE: ASTM C627: "A Standard Test Method for Evaluating Ceramic Floor Tile Installation Systems Using the Robinson-Type Floor Tester"

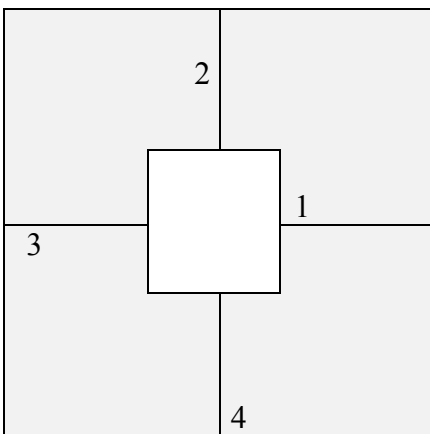
Figure 1: Each tile was 20" x 20" x 0.2" (508 mm x 508 mm x 5.6 mm). A notch was cut from one corner of each tile to accommodate for the ASTM C627 testing apparatus. Each grout joint is labeled below with a number which is the same grout joint number referenced throughout the rest of the report.

Table 1: Lippage Measurements (measured using feeler gauges)

Initial Lippage	Lippage after 1 st Week	Lippage after 2 nd Week	Lippage after 3 rd Week	Final Lippage
Date Measured	10/14/15	10/15/15	10/22/15	10/29/15	11/4/15
Grout Joint 1	0.008" (0.2 mm)	0.008" (0.2 mm)	0.008" (0.2 mm)	0.008" (0.2 mm)	0.008" (0.2 mm)
Grout Joint 2	0.008" (0.2 mm)	0.008" (0.2 mm)	0.008" (0.2 mm)	0.008" (0.2 mm)	0.008" (0.2 mm)
Grout Joint 3	0.002" (0.05 mm)	0.002" (0.05 mm)	0.002" (0.05 mm)	0.002" (0.05 mm)	0.002" (0.05 mm)
Grout Joint 4	0.002" (0.1 mm)	0.004" (0.1 mm)	0.004" (0.1 mm)	0.004" (0.1 mm)	0.004" (0.1 mm)

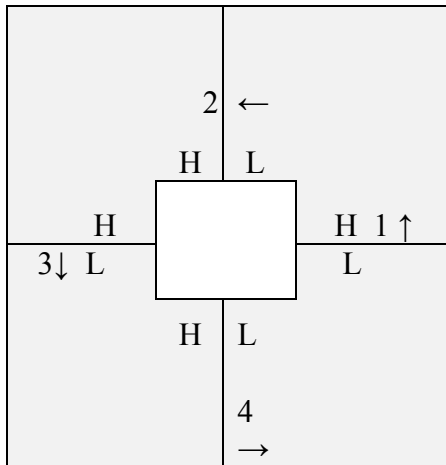
Figure 2: The figure below shows which tiles were higher or lower when the lippage in the wheel path was measured (as shown in table 1). The lower tile is identified with the letter “L” and the higher tile is identified with the letter “H”. The arrows represent the direction that the sled was traveling during testing.

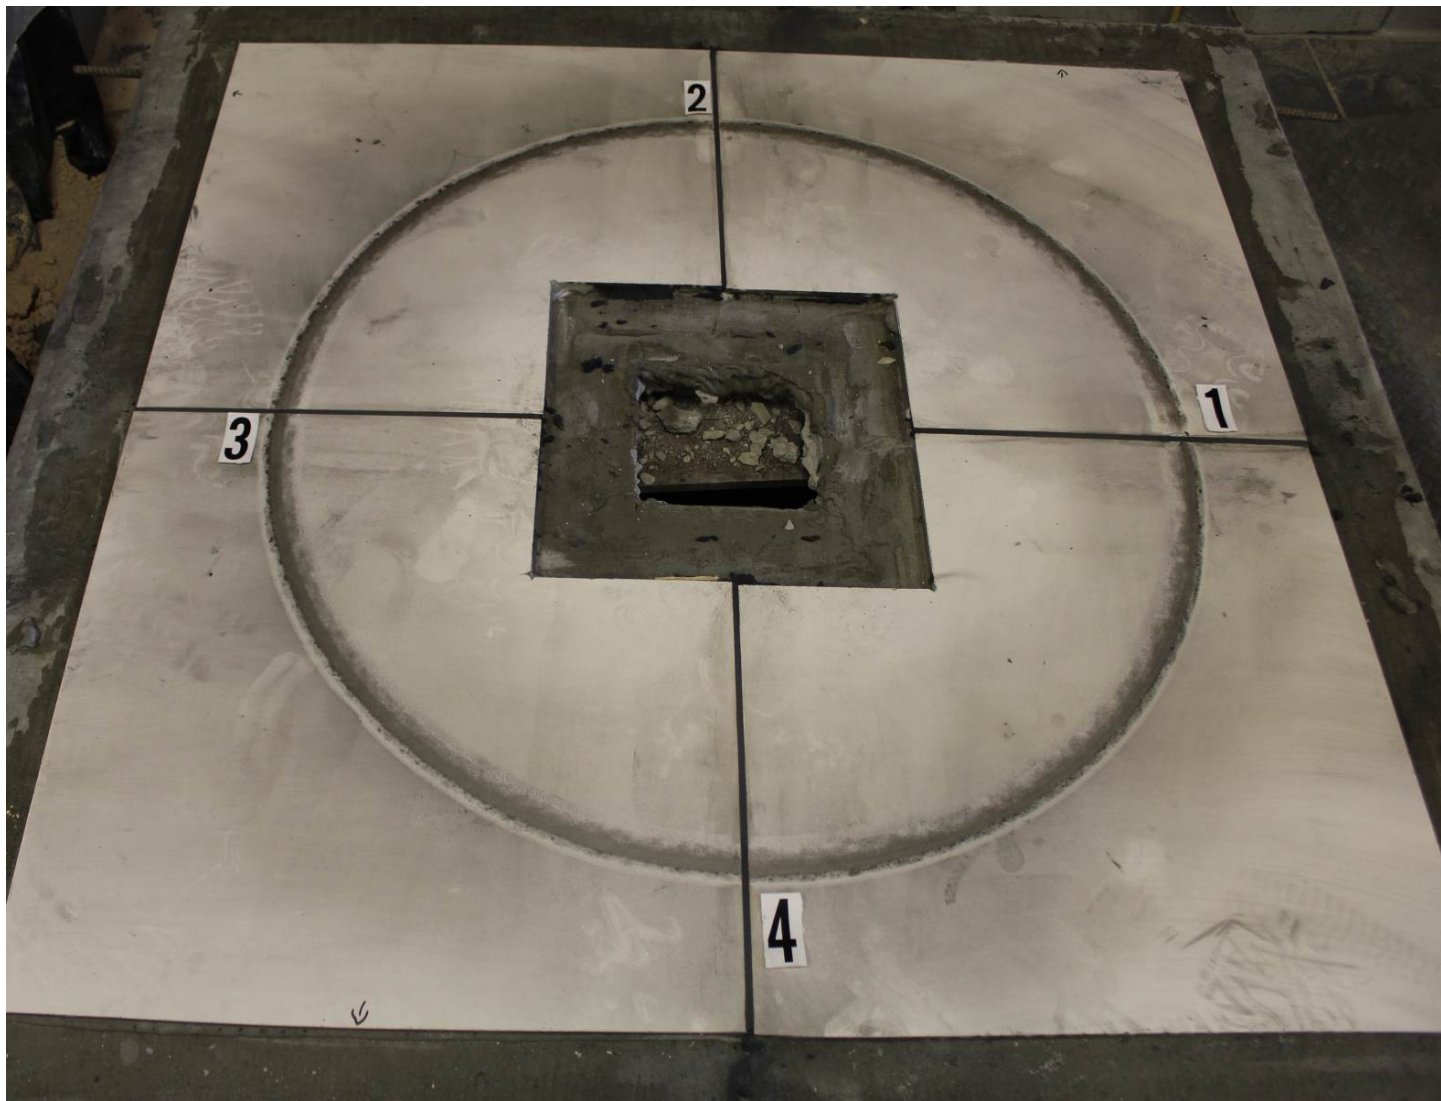
Image 1: Full assembly showing the installed Laminam 5.6 mm tile after testing. The numbers shown coincide with the numbers in Figure 1 and 2 and Table 1.

The installation completed thirteen cycles with no evidence of damage to the tiles or grout joints. At the completion of cycle fourteen (steel wheels, three hundred pounds per wheel), there were two chipped tile (refer to image 2 and 3). All evaluation criteria were based on 4 tiles and 4 grout joints in the wheel path of the Robinson-Type Floor Tester.

In accordance with the Performance-Level Requirement Guide and Selection Table of the 2015 *TCNA Handbook for Ceramic, Glass, and Stone Tile Installation* (page 41), the test pad reached the “HEAVY” classification.

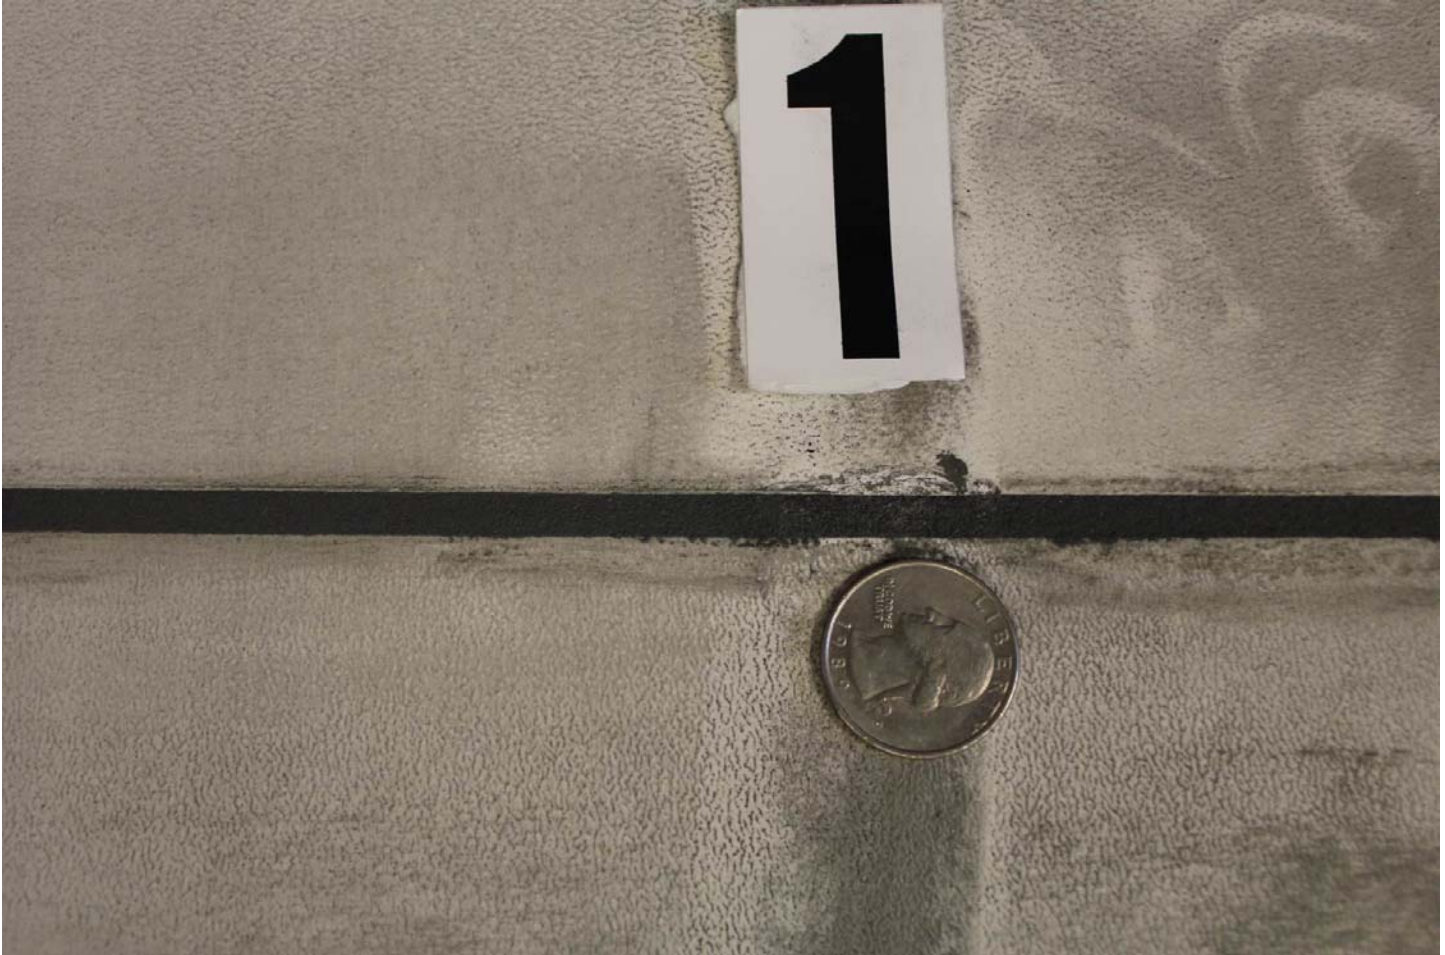
Image 2: Chipped tile at grout joint labeled “1” in figure 1. The damage took place during cycle fourteen.

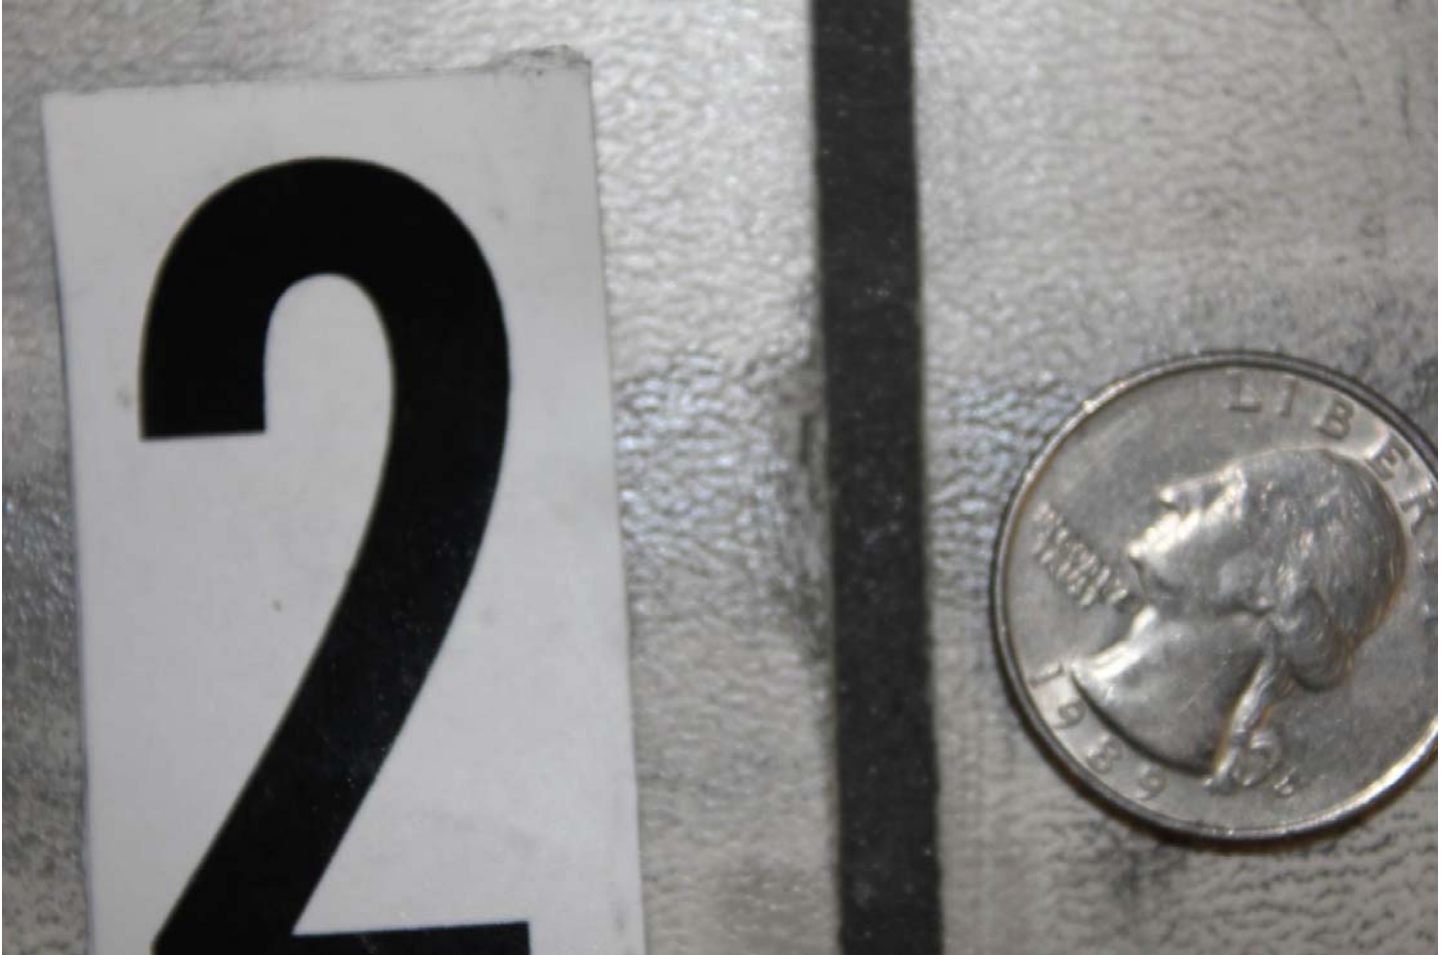
Image 2: Chipped tile at grout joint labeled “2” in figure 1. The damage took place during cycle fourteen.
